## VAF-New England Field Trip

### Massachusetts South Shore Joiners Shops: Standish-Briggs Shop, Pembroke Luther Sampson Shop, Duxbury

## Standish-Briggs Shop

# Luther Sampson Shop

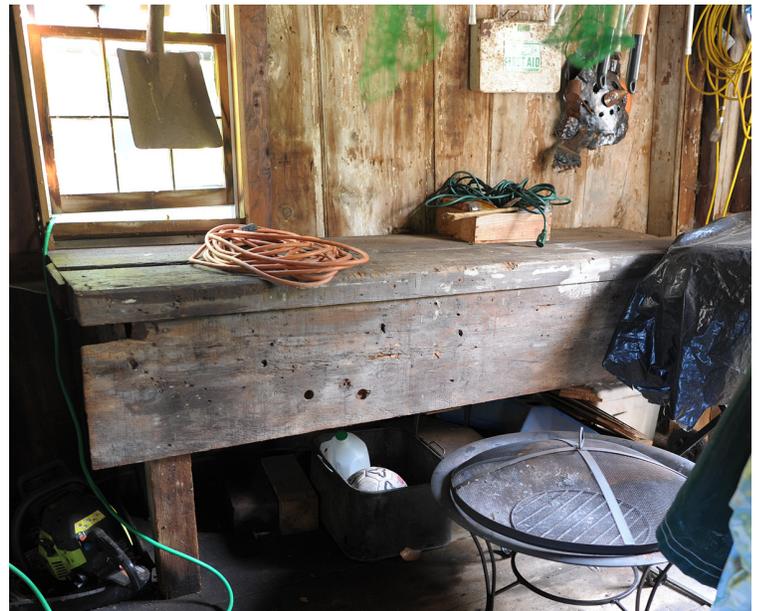
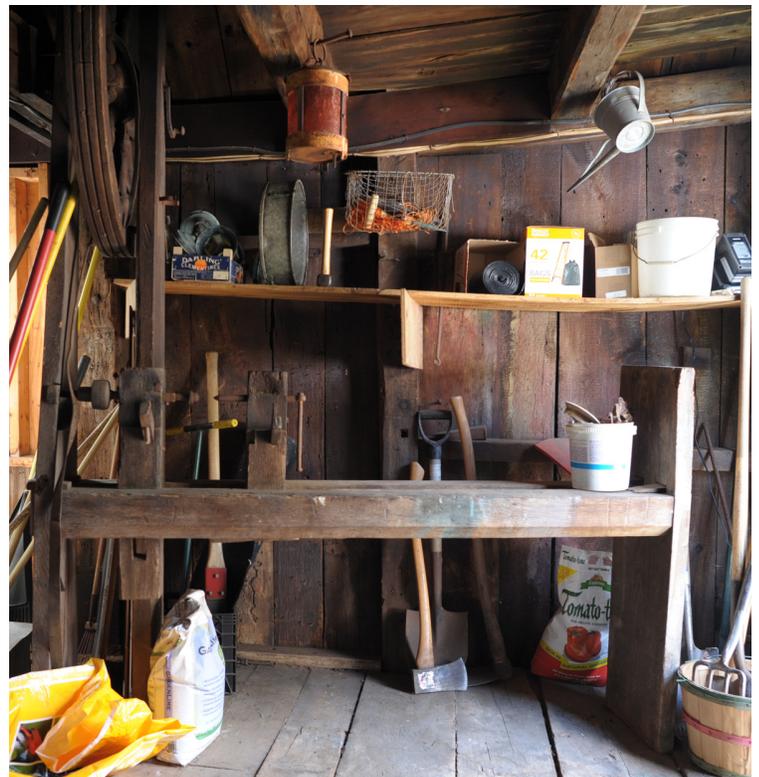
The shop has a nineteenth-century workbench, assembled with cut nails. The really rare feature in the shop, however, is the overhead wheel lathe that probably dates to the late eighteenth century and that might be one of only four or five eighteenth-century lathes that survive in the United States.

Although it has had repairs in the nineteenth century, the lathe is noteworthy for its integrity. The maker designed the it to be taken apart if necessary so it could be moved. It uses tusk tenons and wedges to assemble the major components. The wheel is similar to but much larger than common spinning wheels. The spokes are turned like late eighteenth-century Windsor chair legs in the area, and the fellies are lapped boards nailed together with wrought nails. To balance the wheel's eccentric crank, the maker drilled holes into sections of the fellies and filled the holes with lead. The three grooves in the drive wheel are for cords that powered the pulley on the headstock, unlike the smooth wheels for leather belts typical of the nineteenth century. The original pitman is now long gone and there is no treadle. It was probably a separate unit and may have been nailed or bolted to the floor. The lathe's standards show signs of being toe nailed into the floor to keep it from tipping over as the wheel makes it top heavy. There is an oiling hole in the headstock to keep the drive shaft lubricated and signs of grease on the slots that hold the drive wheel. The lathe and drive wheel are too tall for the short ceiling height of the building and the floor was cut out in order to accommodate the wheel.

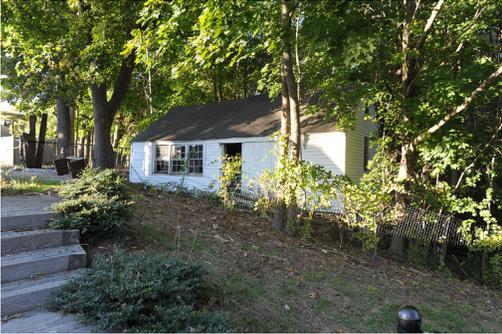
FLOOR PLAN  
1/2"=1'0"

Luther Sampson's shop was 16 feet by 29 feet 6 inches long, partitioned nearly in the middle into two rooms, one of which held a chimney and a fireplace that opened into the main work room. At 480 square feet on a floor, it was comparable to the Boston shops recorded in the 1798 Direct Tax Census and many other joiners' shops in rural Massachusetts. Sampson framed the shop on the side of a hill with a stone foundation under the northern or shop side of the two-room structure and on the south side with a basement room under the one above. The purpose of this basement room remains unclear, but it seems to have included a fireplace from a first period chimney that was replaced, probably in the 1870s, with a stove flue. The joists under the shop are peeled oak poles approximately 8 inches in diameter, but the ones under the south or outer room were hewn.

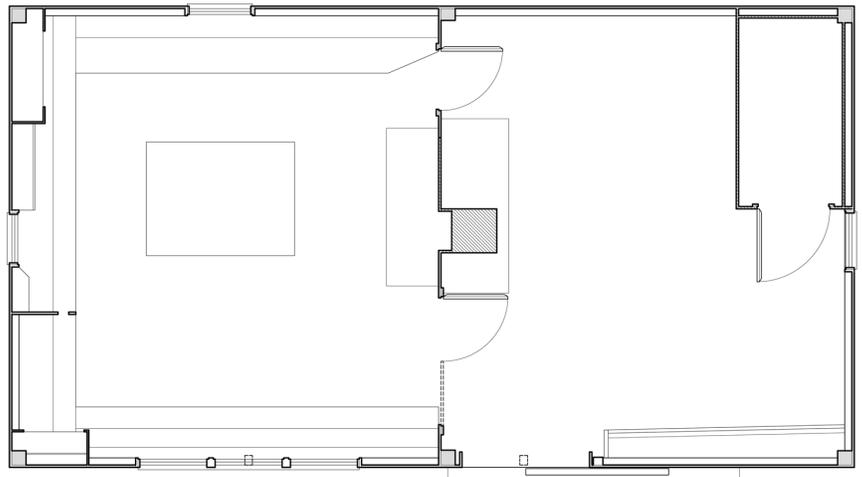
The frame was simple. Three pairs of shouldered, oak posts about 7 feet tall support the oak wall plates and the 6 by 7 inch oak girts that tie the walls together. Nailing rails set approximately 3 feet off the floor between the posts stiffen the walls and provide support for the vertical board sheathing that runs from the sills to the plates. The rails also supported all the windows that were originally smaller and located above these rails. The floor over the shop held in the heat from the fireplace. The joists are located on 21-24 inch centers with thicker joists set under rafter pairs. The southern room has heavier joists set on 42 inch centers that did not originally have a floor. One of the joists in the outer room has a painted date of 1789. The open nature of the joists in the south room supported storage of lumber or finished sections of paneling that could project into the area under the roof. The floor over the shop enabled workers to walk around but the low ceiling height suggests that the ability to hold in a measure of warmth may have been as important a factor as convenient storage.

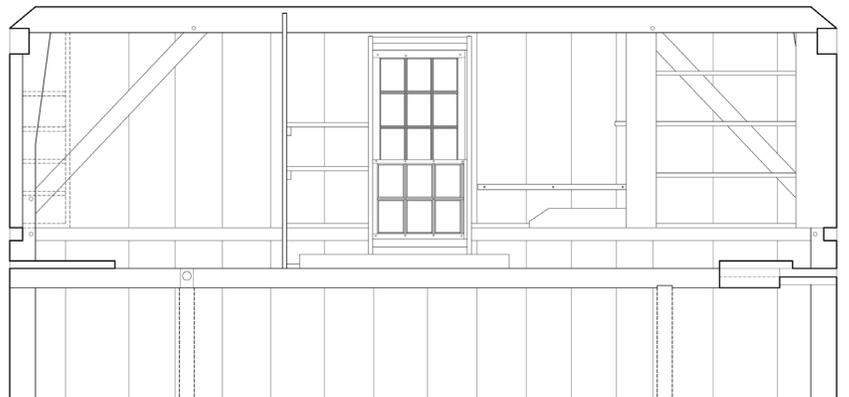
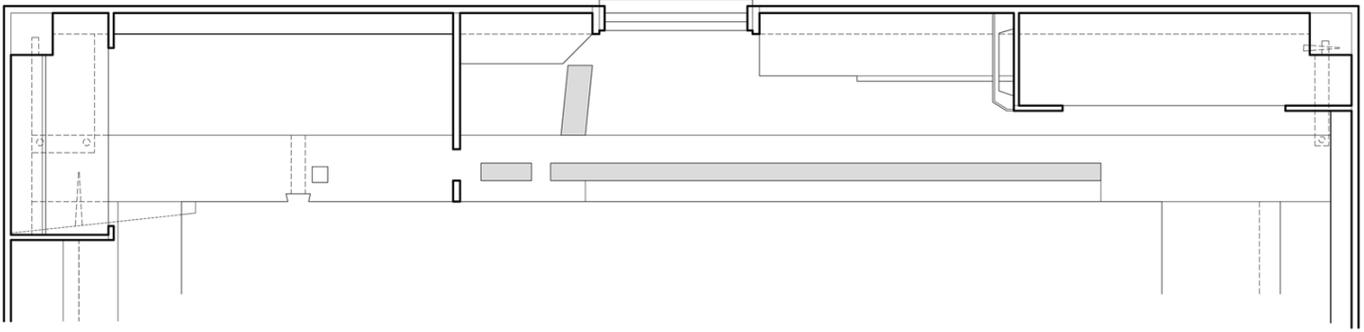
Above Right: First floor plan  
Right: West section showing the original planing bench

The survival of interior fittings including tool racks, workbenches, and shelving are part of the shop's enduring importance as a document. In general, the earliest fittings are separated from later ones by the wrought nails used to attach them to the walls; latter ones had cut nails. The two earliest benches on the northeast and northwest walls of the shop also show different wear patterns. The northwest bench in the Sampson shop was originally a planning bench, converted later to a lathe when the work changed. It is 5 1/4 inches thick and 9 1/2 inches wide, an ideal size for planning the pieces used in frame-and-panel construction. Normally workers do not use chisels or saws on these benches because a scared bench top mars the soft pine commonly found in local paneling. The planning bench has very few scars from stray tools and it is furthest from the fireplace. Shavings pile up, but they are still far from danger. It is also no accident that the shelves for the molding and bench planes are located to either end of this planning bench. Scars show where Sampson and others placed molding planes.

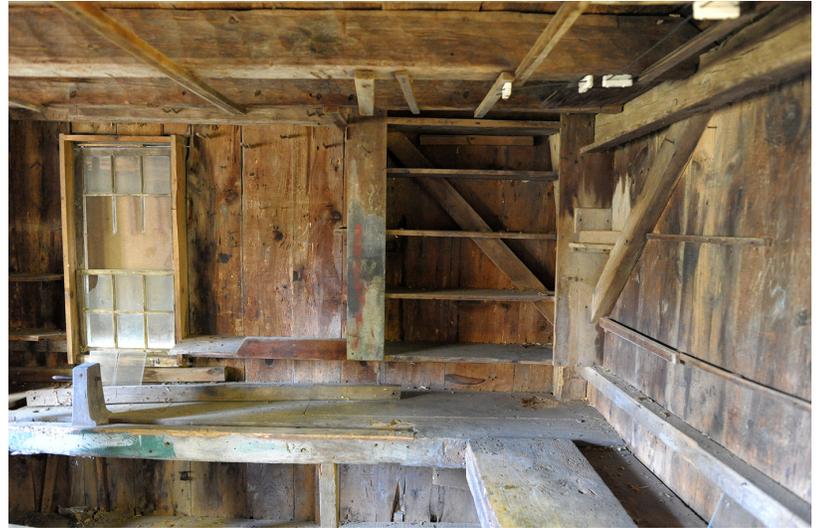
The Sampson shop clearly had a fireplace in its first period, marked by cuts in the paneling where the original opening was. While the fireplace suggests that workers sought a measure of warmth during winter months, the nature of the work also drove the design. Hide glues do not cure well at low temperatures. Similarly, paint finishes required a certain amount of warmth to cure properly. Finally, smoothing lumber with hand planes generates a large volume of shavings and wood chips that need to be gotten rid of. Burning them up in the fireplace is a useful way to keep the place somewhat clean and heat it.

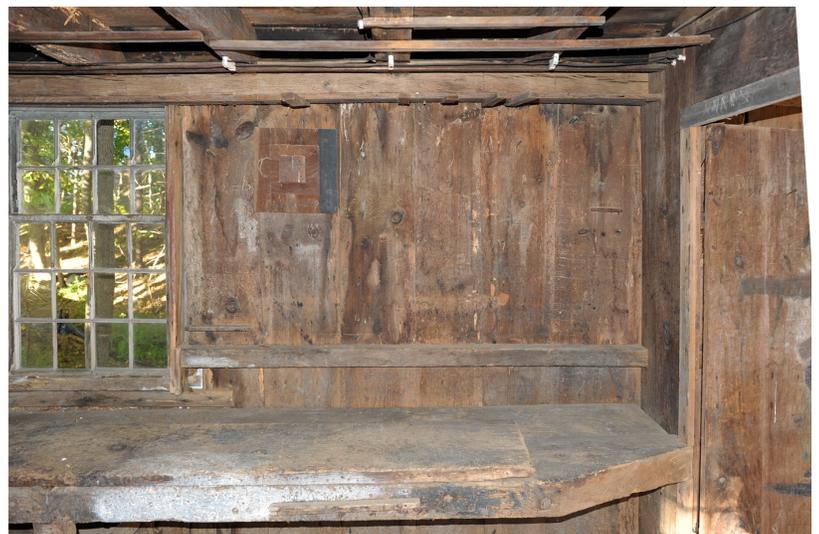
Conversely, the northeast bench is so chopped up, that later workers added a sacrificial plank to reface it. It was here that Sampson and later workers nailed racks onto the board walls (starting from left to right) for chisels, bits, awls, squares, saws and a saw wrest. The racks are similar to those in the Dominy shop at the Winterthur Museum. Workers used this bench for cutting tenons, chopping out mortises, and pinning the joints with pegs.
